Manhole Inspection Summary

Manhole # S39WW_034MH

Insp Date: **12/18/06 12:53 PM**

Location Address: **800 HOMESTEAD ST**

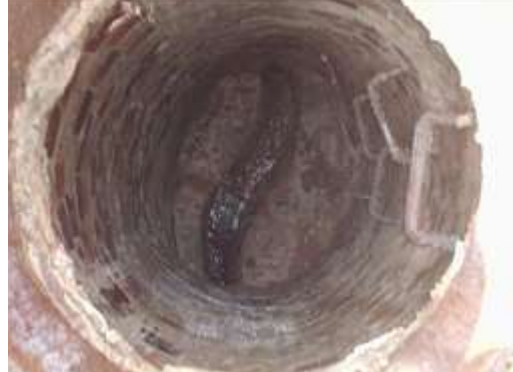
Top View

Corroded steps. Evidence of surcharge - Bench debris. Channel debris.

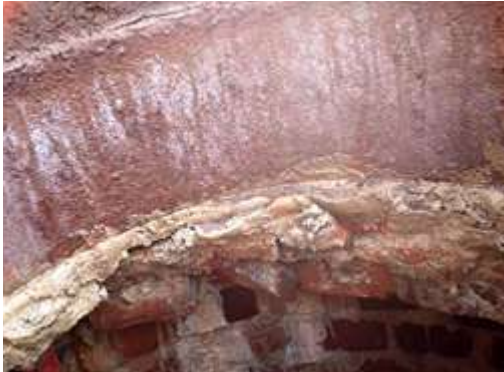
Defect

Frame leaks. Adjustment deterioration and infiltration.

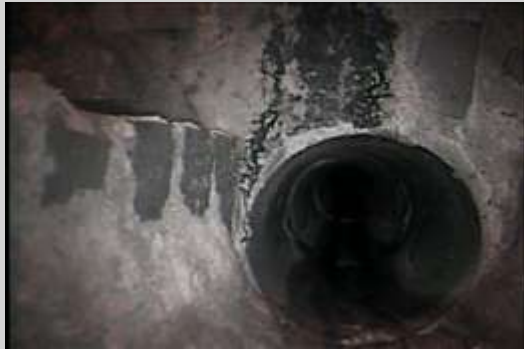
8 in. Circular Gravity Sewer Pipe Out @ 12 O'Clock

Pipe Material: **Clay** ☐ Pipe Lined

Invert Depth: **10.26** (ft.) Flow Characteristics: **Slow**

Deposits: ☒ None ☐ Mud ☐ Sludge ☐ Debris ☐ Grease

Infiltration: **None**

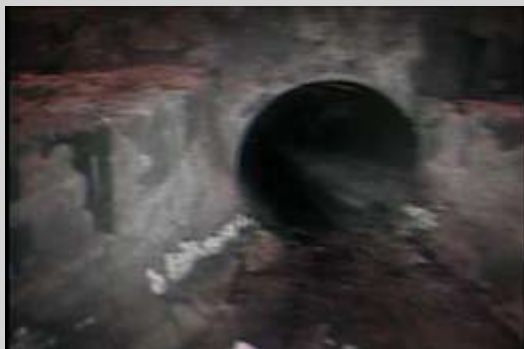
8 in. Circular Gravity Sewer Pipe In @ 6 O'Clock

Pipe Material: **Clay** ☐ Pipe Lined

Invert Depth: **9.88** (ft.) Flow Characteristics: **Slow**

Deposits: ☐ None ☐ Mud ☐ Sludge ☒ Debris ☒ Grease

Silt Depth: **0.05** (in.) Deposits Extent: **Light**

Infiltration: **Evidence**

Pipe Seal Cond: **Cracked**
